# Manhole Inspection Summary

Manhole # S09CC2036MH

**Inspection** ☐ Is Incomplete Rating: **4) Poor**

**Location** Address: **5900 GREENSPRING AVE**

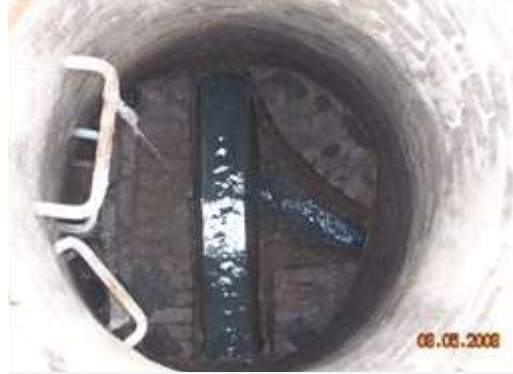
Top View

Corroded steps. Evidence of surcharge - Bench debris. Channel debris.

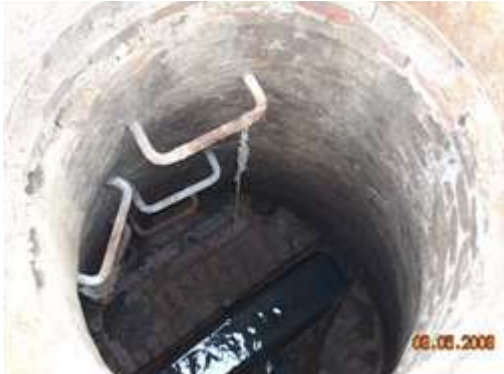
Defect

Frame leaks. Frame offset. Adjustment deterioration and infiltration. Corbel and Barrel infiltration.

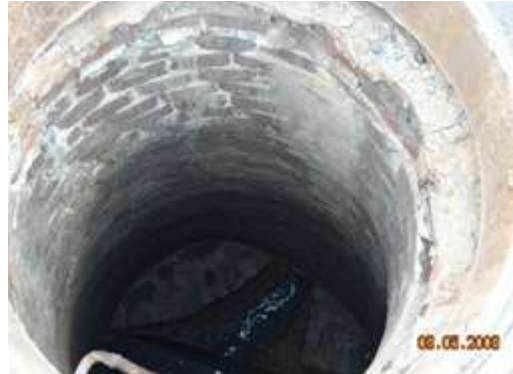
Defect

Frame leaks. Frame offset. Adjustment deterioration and infiltration. Corbel and Barrel infiltration - other side.

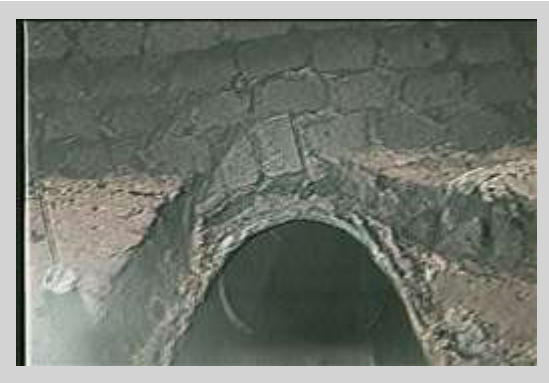
### 12 in. Circular Gravity Sewer Pipe Out @ 12 O'Clock

Barrel deterioration and infiltration. Channel deterioration.

Infiltration: **Evidence** Pipe Seal Cond: **Broken**

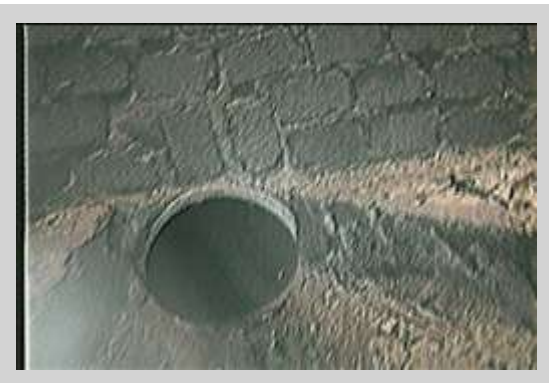
### 8 in. Circular Gravity Sewer Pipe In @ 3 O'Clock

Barrel deterioration and infiltration. Channel deterioration.
